Manhole Inspection Summary

Manhole # S35A__013MH

Location Address: **607 n charles st**

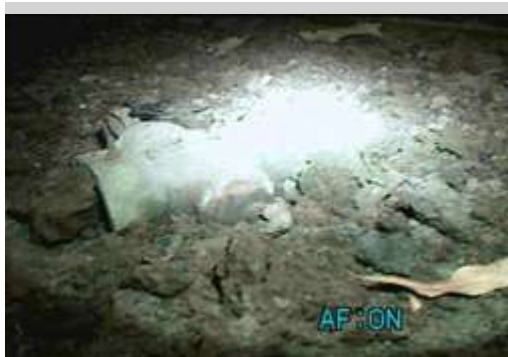
Defect 3

Condition: ☐ Sound ☐ Cracked ☐ Root Intrusion ☐ Deteriorated ☐ Leaks ☒ **Debris**

channel debris

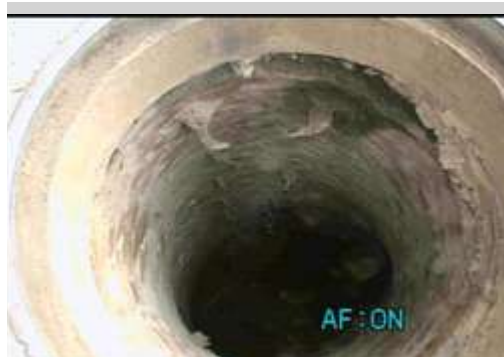
Defect 2

Count: **7** Missing: **7** ☒ **Corroded**

missing steps

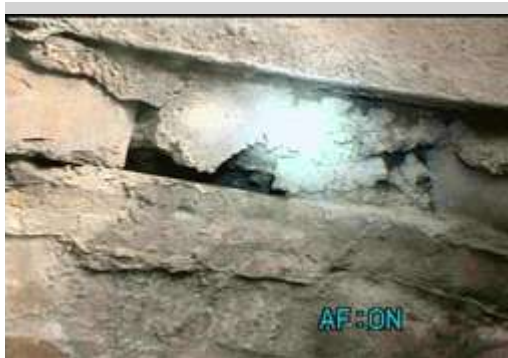
Defect 1

Condition: ☐ Sound ☐ Cracked ☐ Root Intrusion ☐ Loose Brick ☒ **Deteriorated**

deteriorated

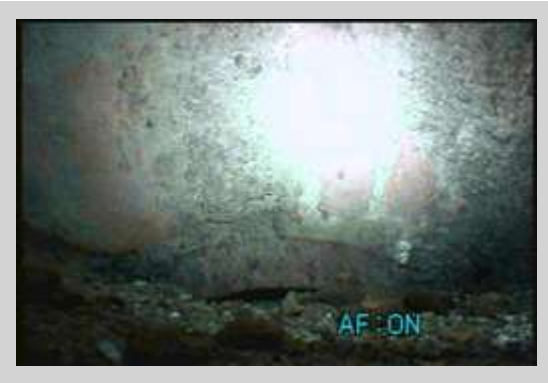
12 O'Clock Outflow

heavy debris
debris to top of twelve
